A recent research project involving the Bushfire Cooperative Research Centre (Bushfire CRC) and the CSIRO has revealed that different types of rainwater tanks can play an important role in defending houses against the threat of a bushfire.

RESEARCH AND INVESTIGATION INTO THE PERFORMANCE OF RAIN WATER TANKS IN BUSHFIRES

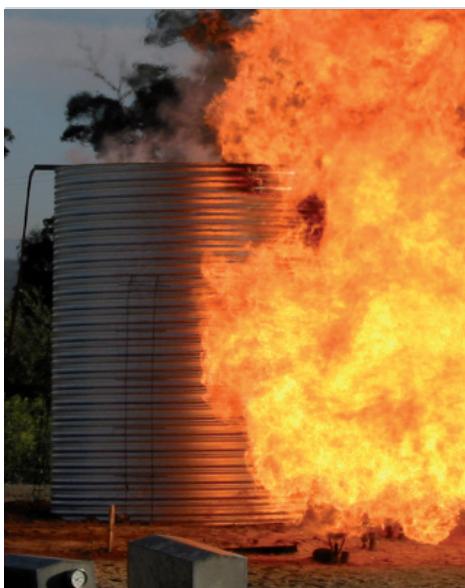
Of the different materials tested, spiral wound, steel tanks performed best under all exposure conditions. All steel manufactured tanks maintained structural integrity when faced with a 30-minute flame immersion test, simulating an adjacent structural fire (see table overleaf for further details on exposure levels).

LEFT: WATERPOINT® CLASSIC DURING TESTING AND
ABOVE RIGHT: STEEL CONSTRUCTION TANK AFTER FIRE FRONT

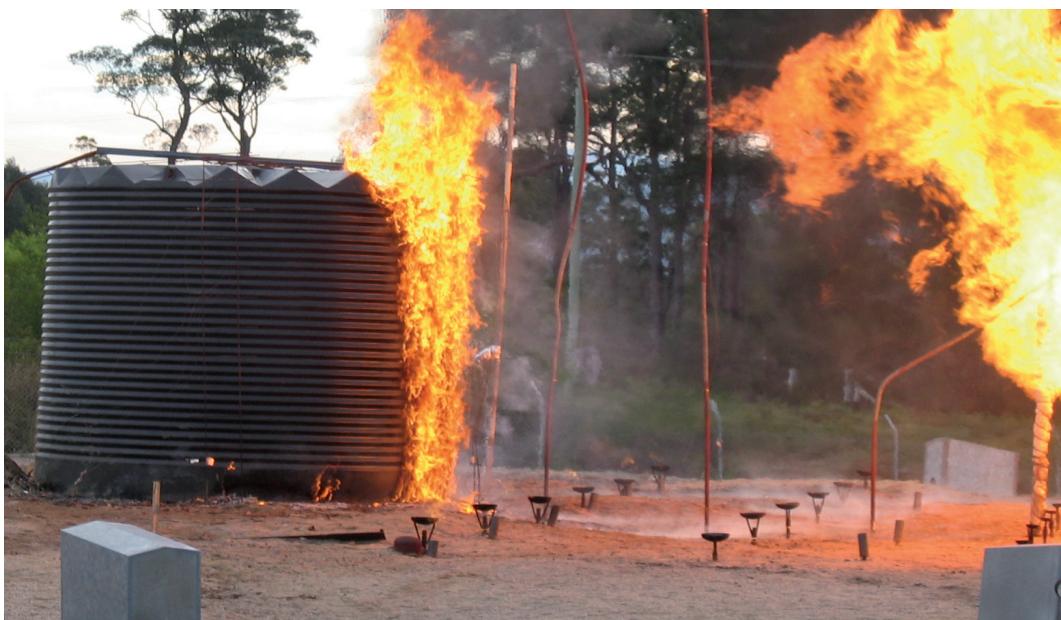
Polyethylene tanks suffered considerable structural distortion during simulation of a bushfire passage. The tanks demonstrated structural deformation during the 30 minute flame exposure, resulting in the tank splitting itself and melting down. Polyethylene tanks were at risk of total failure when adjacent combustible items are present, in the form of forest litter, fences or other polyethylene tanks.

LEFT: TESTING OF POLYETHYLENE RAINWATER TANKS
