A recent research project involving the Bushfire Cooperative Research Centre (Bushfire CRC) and the CSIRO has revealed that different types of rainwater tanks can play an important role in defending houses against the threat of a bushfire.

RESEARCH AND INVESTIGATION INTO THE PERFORMANCE OF RAIN WATER TANKS IN BUSHFIRES

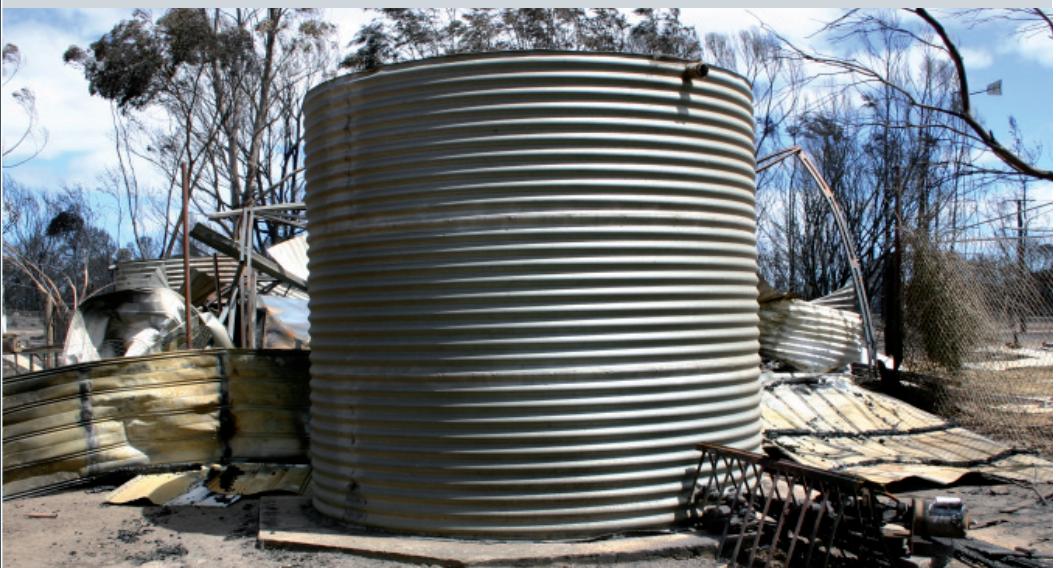
Of the different materials tested, spiral wound, steel tanks performed best under all exposure conditions. All steel manufactured tanks maintained structural integrity when faced with a 30-minute flame immersion test, simulating an adjacent structural fire (see table overleaf for further details on exposure levels).

LEFT: WATERPOINT® CLASSIC DURING TESTING AND
ABOVE RIGHT: STEEL CONSTRUCTION TANK AFTER FIRE FRONT
